## Inspection Report For:

Alpine Mutual Water Co

50 KG Concrete Below-Grade Tank

Date Completed: 06-30-2023

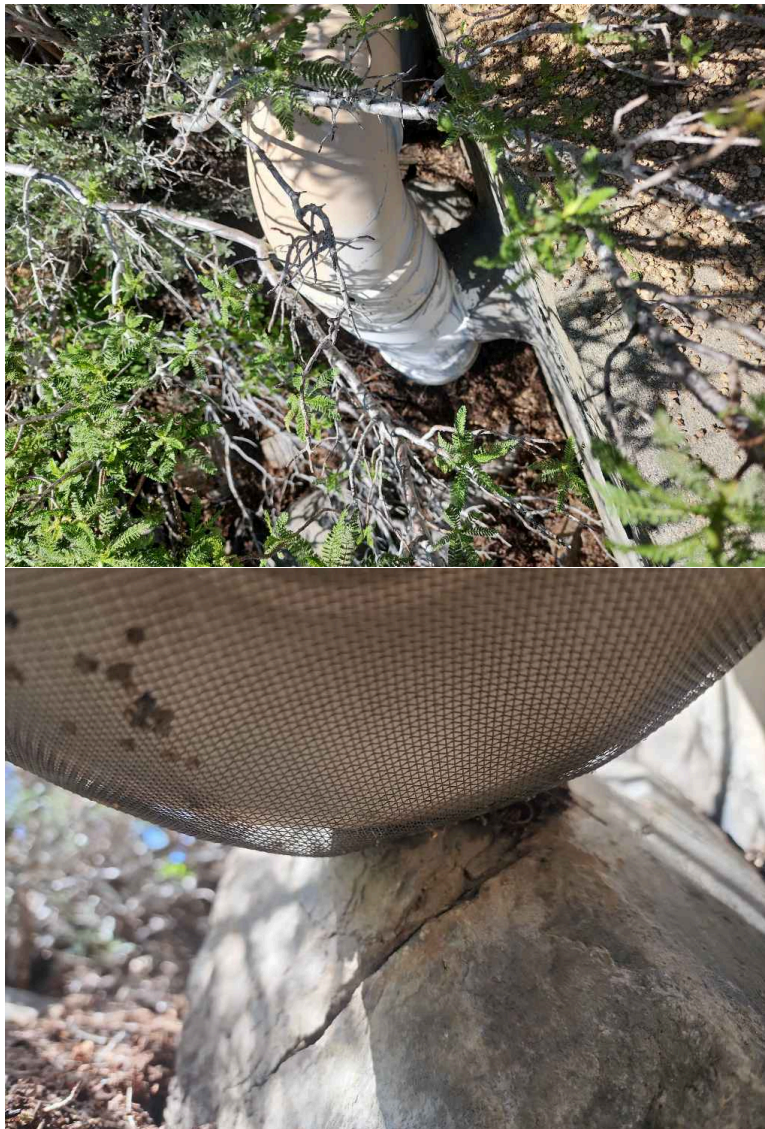
### Overflow Photos

Discharge Opening Type	End Cap
Is there a screen covering the discharge opening?	Yes - #24 Mesh
How high above the ground is the discharge opening?	3"
Are there any obstructions to water flow?	No
Welds/Seams Condition	Good

What is the overall condition of the Overflow?	Good
Overflow Summary	Overflow is a pvc pipe

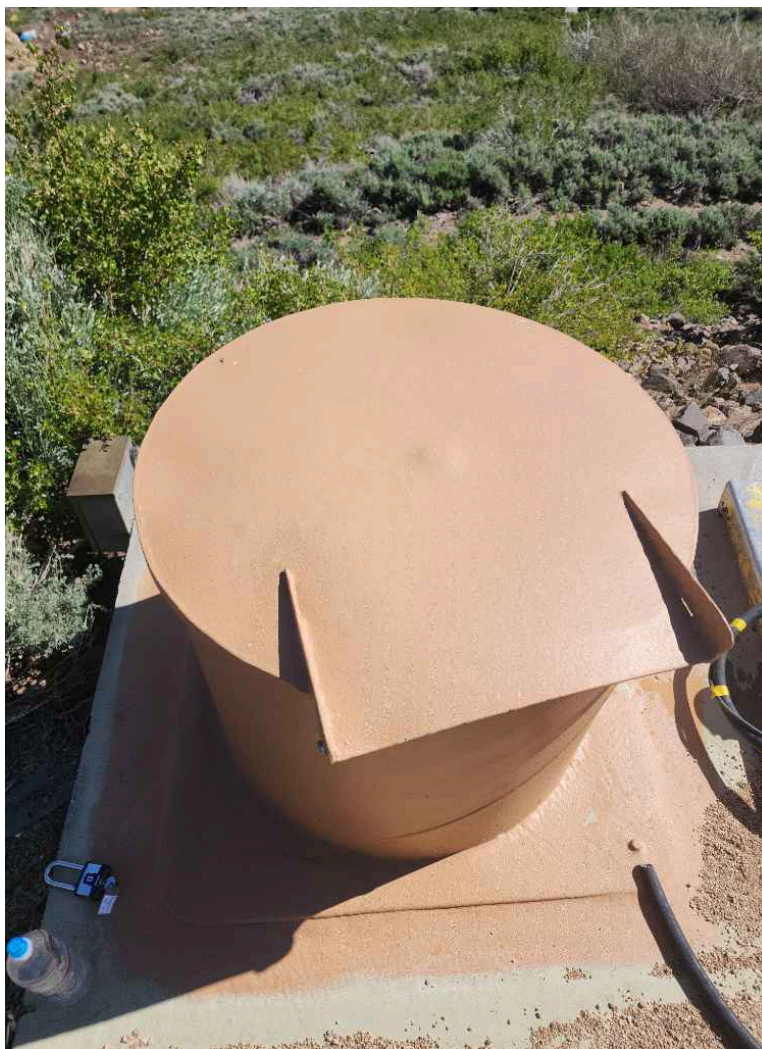
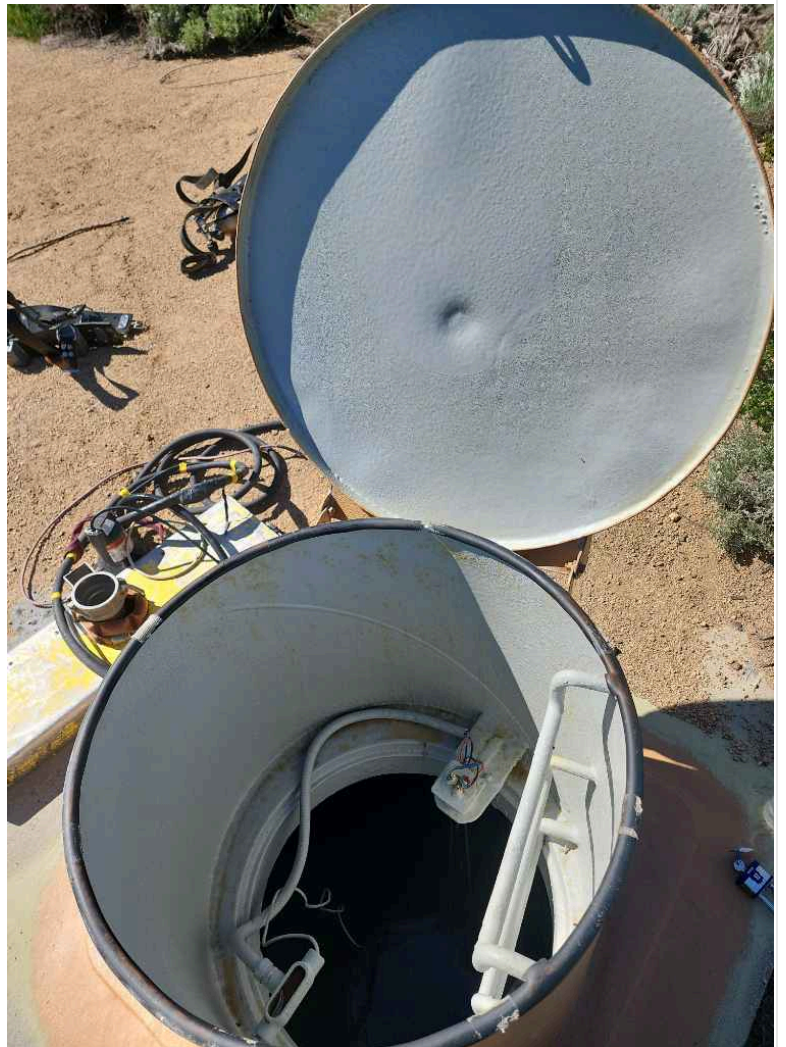
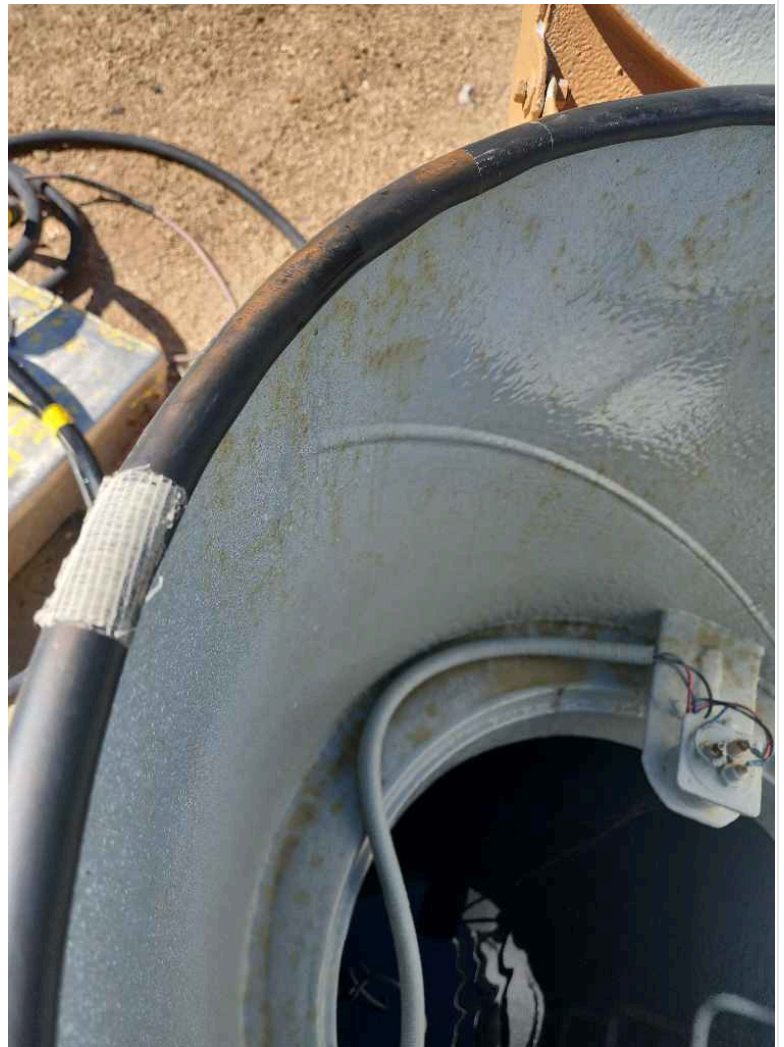
Access Hatch Photos

Access Hatch Shape	Round
Access Hatch Size	29"
Riser Height	24"
Lid Height	1.5"
Was the hatch locked?	Yes
Hinge Condition	Good
Is a gasket present?	Yes
Is the gasket intact?	Yes
Is there any dirt or debris below the hatch?	No
Is the hatch coated?	Yes

Welds/Seams Condition	Good
<b>Hatch Coating Condition</b>	
Oxidation?	None
Delamination?	None
Staining	None
Blistering?	None
Chalking?	None
Cracking in the Coating?	None
Pinholes?	None
Sags/Runs?	None
<b>Hatch Corrosion Discrepancies</b>	
Uniform Surface Corrosion	None
Concentrated Cell Corrosion	None
Rust Noduling	None
Pitting Depth	None
Galvanic Corrosion	None
De-Alloying	None
Intergranular Corrosion	None
Stress Corrosion	None
Erosion Corrosion	None
<b>Access Hatch Overall</b>	
Overall Condition	Excellent

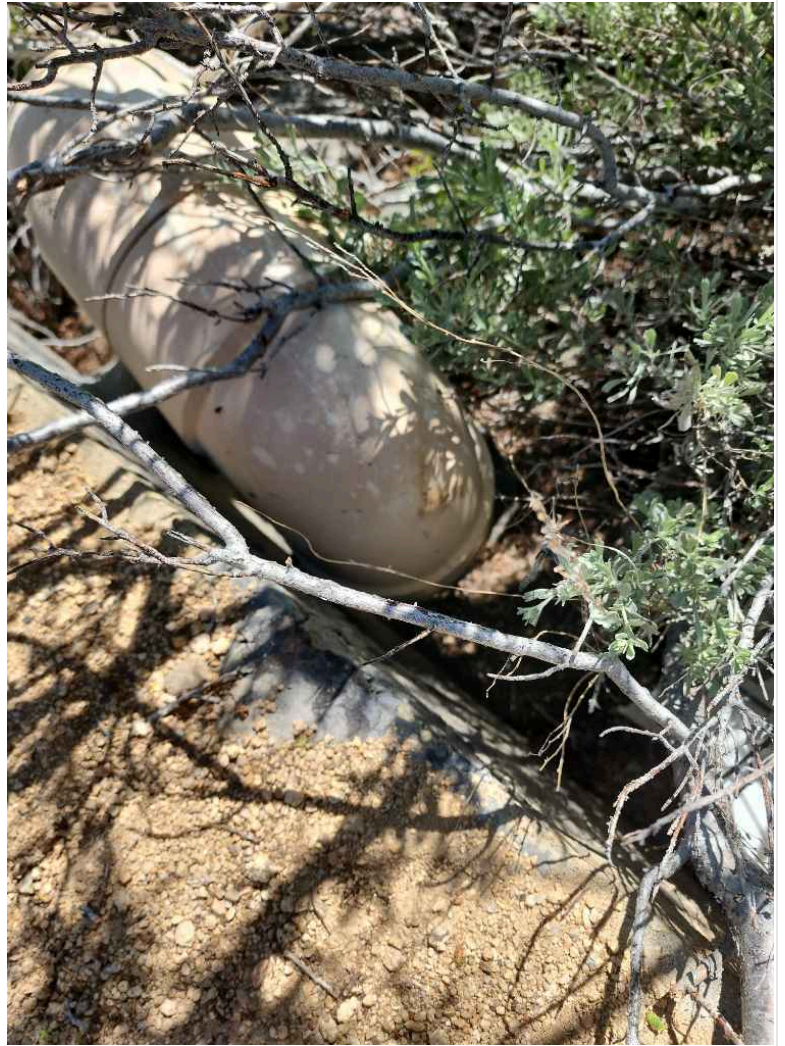
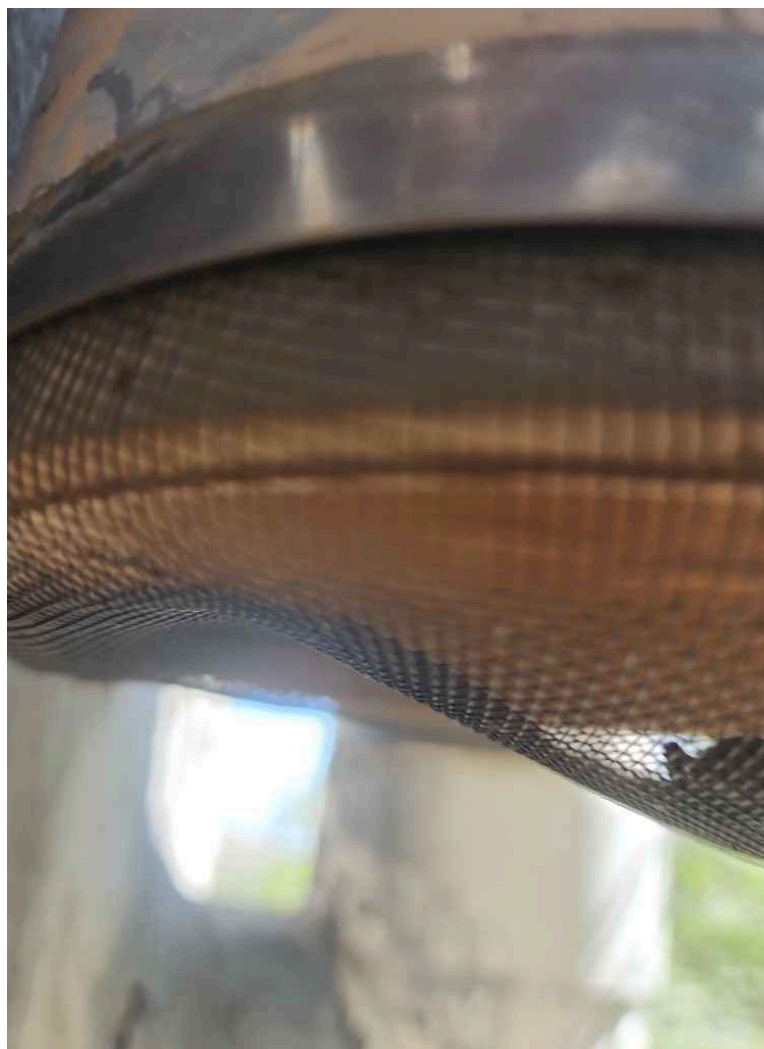
Vent Photos

Is there a vent covering the screen?	Yes - #24 mesh
Vent Screen Condition	Good
Are all openings sealed/covered?	Yes
Cap Condition	Good
Is the vent coated?	No
<b>Vent Corrosion Discrepancies</b>	
Uniform Surface Corrosion	Grade 10 – less than 0.01%
Concentrated Cell Corrosion	Grade 10 – less than 0.01%
Rust Noduling	None
Pitting Depth	None
Galvanic Corrosion	None

De-Alloying	None
Intergranular Corrosion	None
Stress Corrosion	None
Erosion Corrosion	None
<b>Vent Overall</b>	
Vent Overall Condition	Good

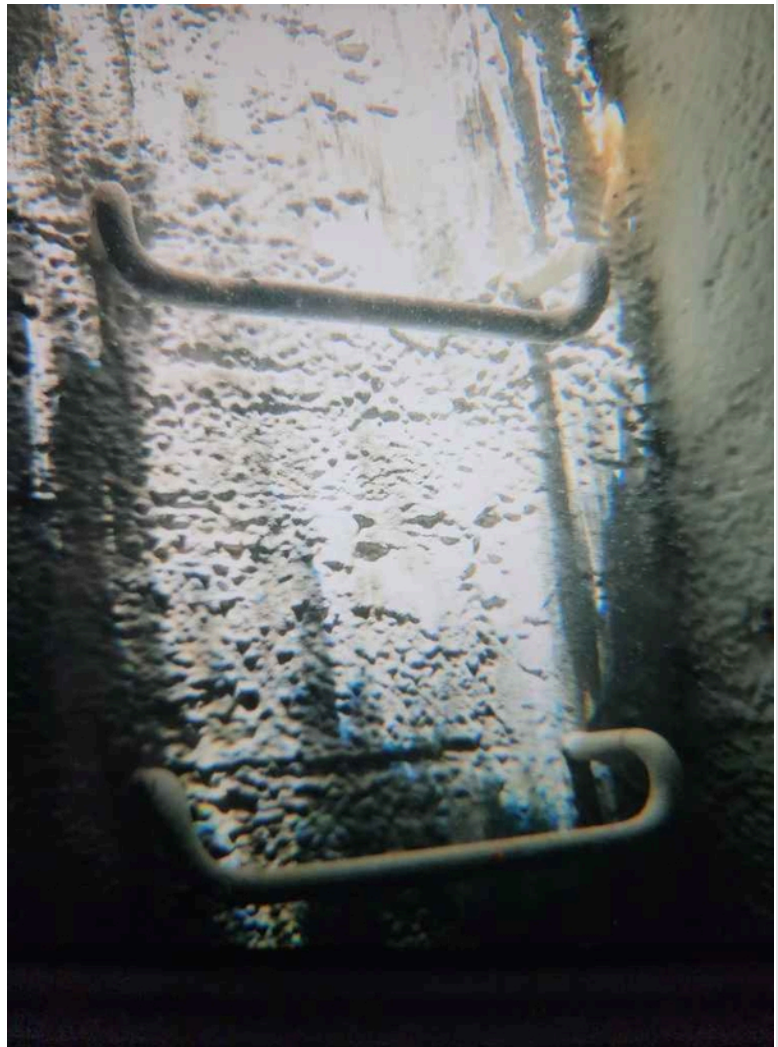
2. The interior ladder is located in the northwest corner. It exhibited good overall condition, with minor sagging and moderate sediment staining on the coating. Less than 0.01% concentrated cell corrosion was detected.

Interior Ladder Location	Northwest
Stand-Offs Condition	Good
Seams/Welds Condition	Good
<b>Access Ladder Coating Condition</b>	
Coating Condition	Good
Oxidation?	None
Delamination?	None
Staining?	Moderate sediment
Blistering?	None
Chalking?	None
Cracking in the Coating?	None

Pinholes?	None
Sags/Runs?	Minor
<b>Access Ladder Corrosion Discrepancies</b>	
Uniform Surface Corrosion	None
Concentrated Cell Corrosion	Grade 10 – less than 0.01%
Rust Noduling	None
Pitting Depth	None
Galvanic Corrosion	None
De-Alloying	None
Intergranular Corrosion	None
Stress Corrosion	None
Erosion Corrosion	None
<b>Access Ladder Overall</b>	
Interior Ladder Overall Condition	Good

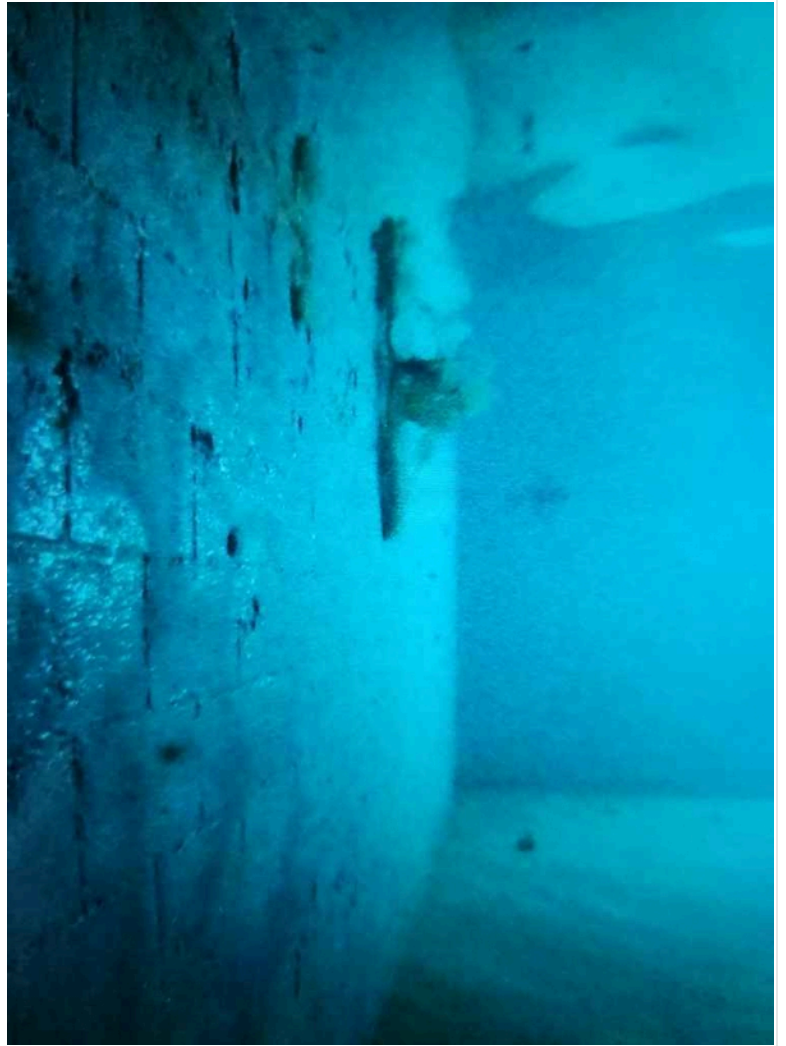
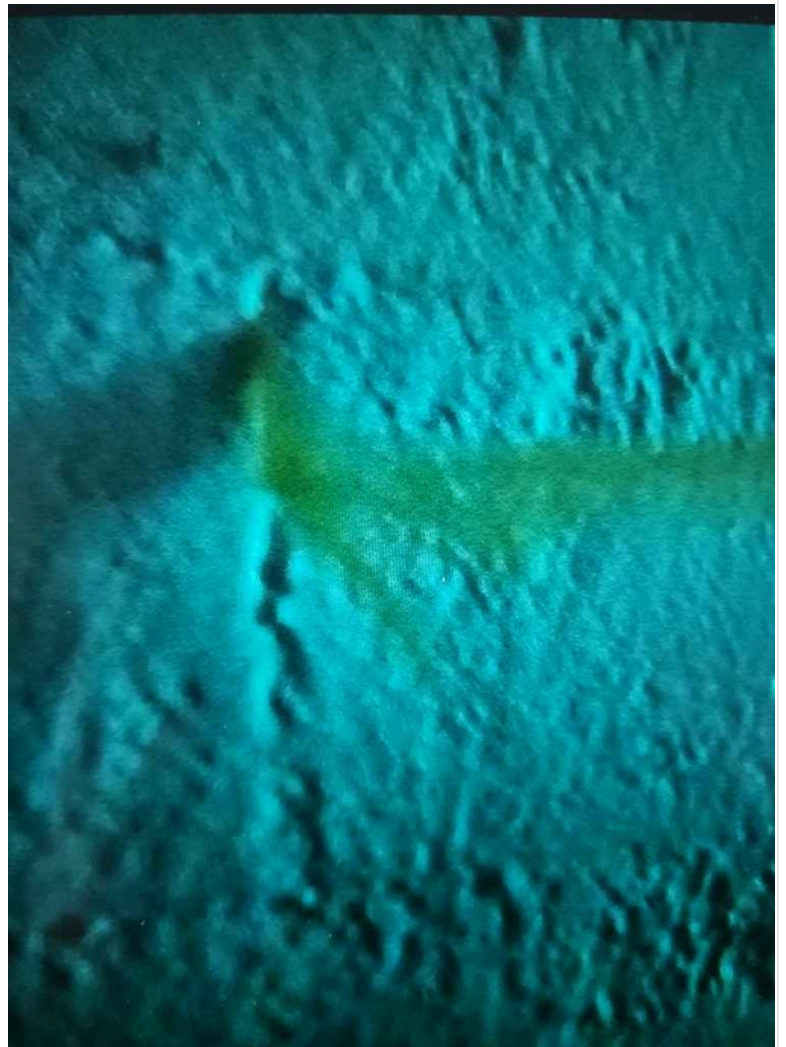
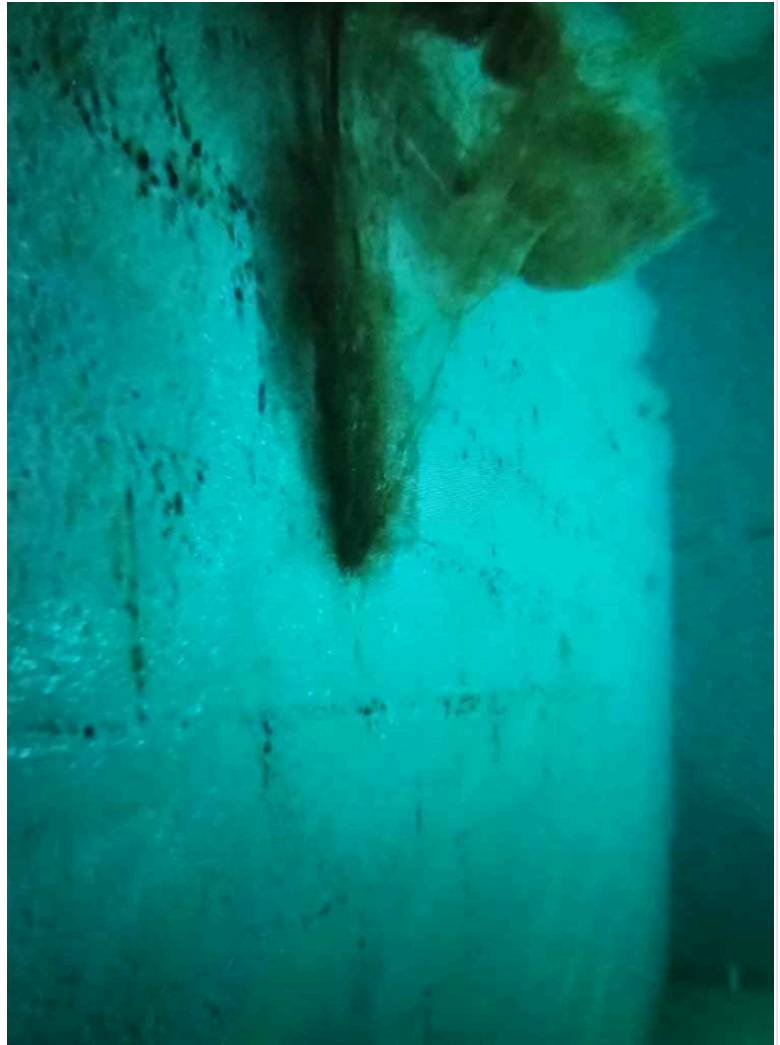
Wall Photos

3. The interior overflow is located in the northeast corner and was in good overall condition. No coating or corrosion deficiencies were found.
4. The interior walls are concrete and were in good overall condition. Minor hairline cracking, popouts, voids, and exposed aggregate were present on the concrete walls, along with moderate organic growth.

Is the wall concrete or steel?	Concrete
Are there any signs of movement?	No
Are there any irregularities or structural deficiencies?	No
Are there any signs of leaking?	No
Is Biofilm present on the walls?	No
Seams/Welds	Good
<b>Interior Wall Concrete Condition</b>	
Hairline Cracking	Minor
Settling Cracking	None
Pressure Cracking	None

Checking	None
Popouts	Minor
Spalling	None
Voids	Minor
Exposed Reinforcement	None
Exposed Aggregate	Minor
<b>Interior Wall Overall Condition</b>	
What is the overall condition of the interior wall?	Good
Interior Wall Summary	Moderate organic growth

Does the tank appear to be structurally sound?	Yes
Are there any unprotected openings in the tank (breaches, leaks, daylight, etc.)?	Yes Holes in the south wall that allow organic material to get in
When viewed from inside the tank, is there visible daylight around the hatches, vents, joints or other fixtures?	No

Standard Clean and Inspect - How often?	Every 3-5 years
Does the tank need any screens, hatch gaskets, or locks?	None
Are epoxy repairs needed?	No
Does the tank need a blast and recoat?	No
Please list/describe any additional recommendations. If none, type "n/a"	Recommend further evaluation recommended to be performed by structural engineer to investigate encroachment of vegetation on concrete joints.

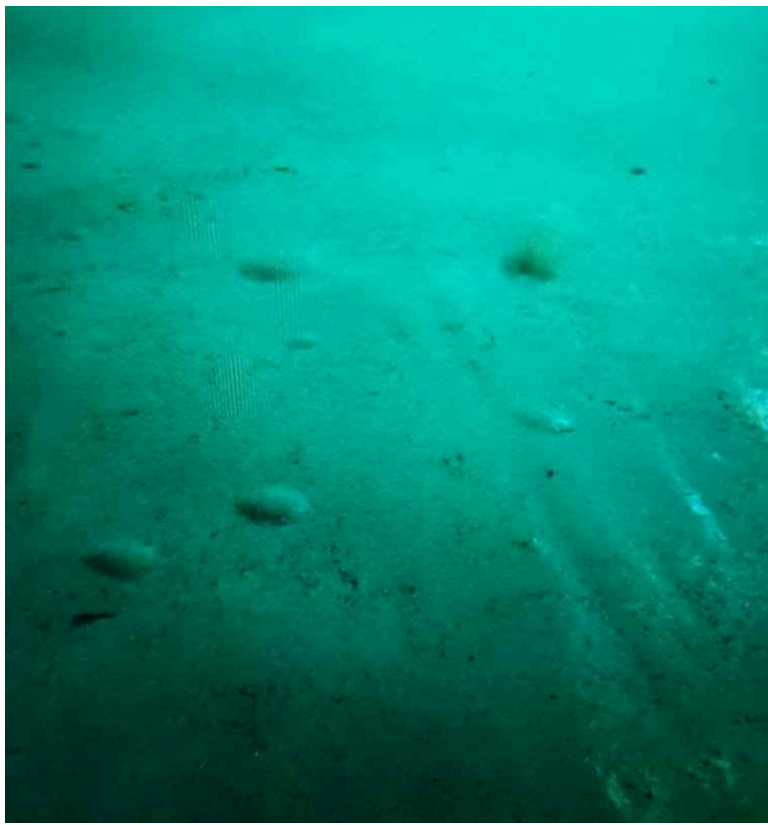
Floor Photo

Is the floor concrete or steel?	Concrete
Are there any signs of movement?	No

Are there any irregularities or structural deficiencies?	No
Are there any signs of leaking?	No
Seams/Welds	Good
<b>Interior Floor Concrete Condition</b>	
Hairline Cracking	None
Settling Cracking	None
Pressure Cracking	None
Checking	None
Popouts	None
Spalling	None
Voids	None
Exposed Reinforcement	None
Exposed Aggregate	None
<b>Interior Floor Overall Condition</b>	
What is the overall condition of the tank floor?	Good
Tank Floor Summary	Moderate Micro and macro blistering

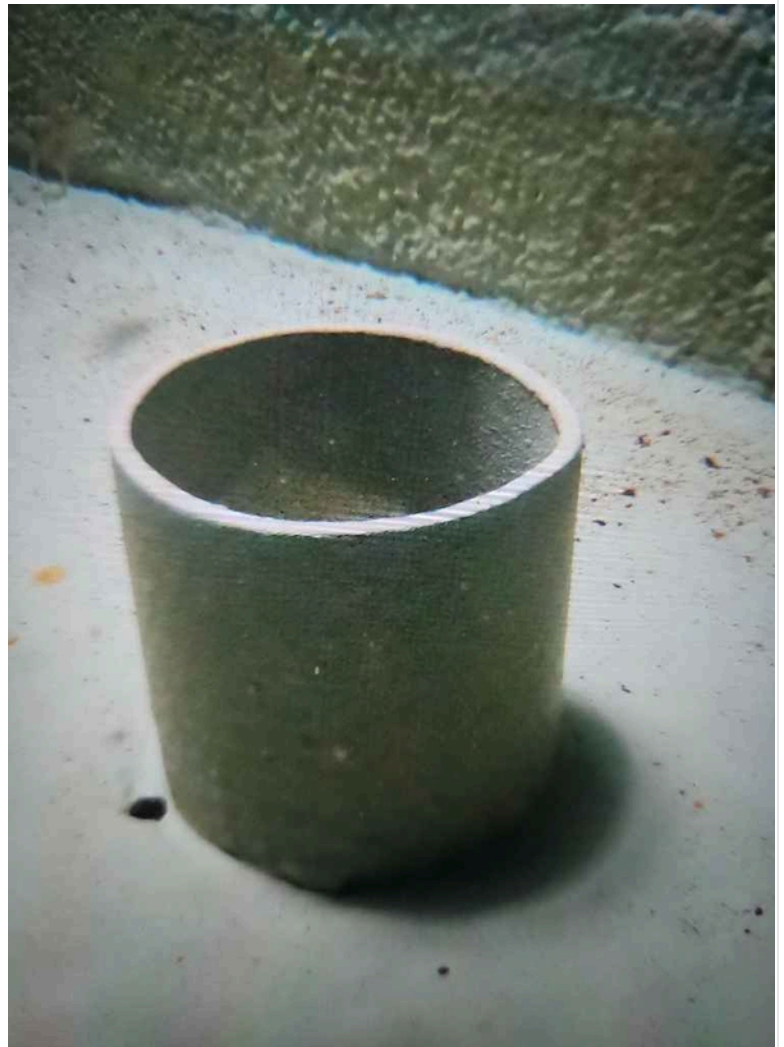
Common Inlet/Outlet Photo

Common Inlet/Outlet Location	west corner
Common Inlet/Outlet Seams/Welds Condition	Good
<b>Common Inlet/Outlet Coating Condition</b>	
Coating Condition	Good
Oxidation?	None
Delamination?	None
Staining?	Minor sediment
Blistering?	None
Chalking?	None
Cracking in the Coating?	None

Pinholes?	None
Sags/Runs?	None
<b>Common Inlet/Outlet Corrosion Discrepancies</b>	
Uniform Surface Corrosion	None
Concentrated Cell Corrosion	None
Rust Noduling	None
Pitting Depth	None
Galvanic Corrosion	None
De-Alloying	None
Intergranular Corrosion	None
Stress Corrosion	None
Erosion Corrosion	None
<b>Common Inlet/Outlet Overall Condition</b>	
What is the overall condition of the common inlet/outlet?	Good
