Tim Rudolph ENGINEERING

Alpine Water Company
100 Nutcracker Road
Bishop, CA 93514

Re: Water System Evaluation

System Evaluation – Purpose is to evaluate the water system & identify problems, improvements or recommendations that will ensure a reliable water system.

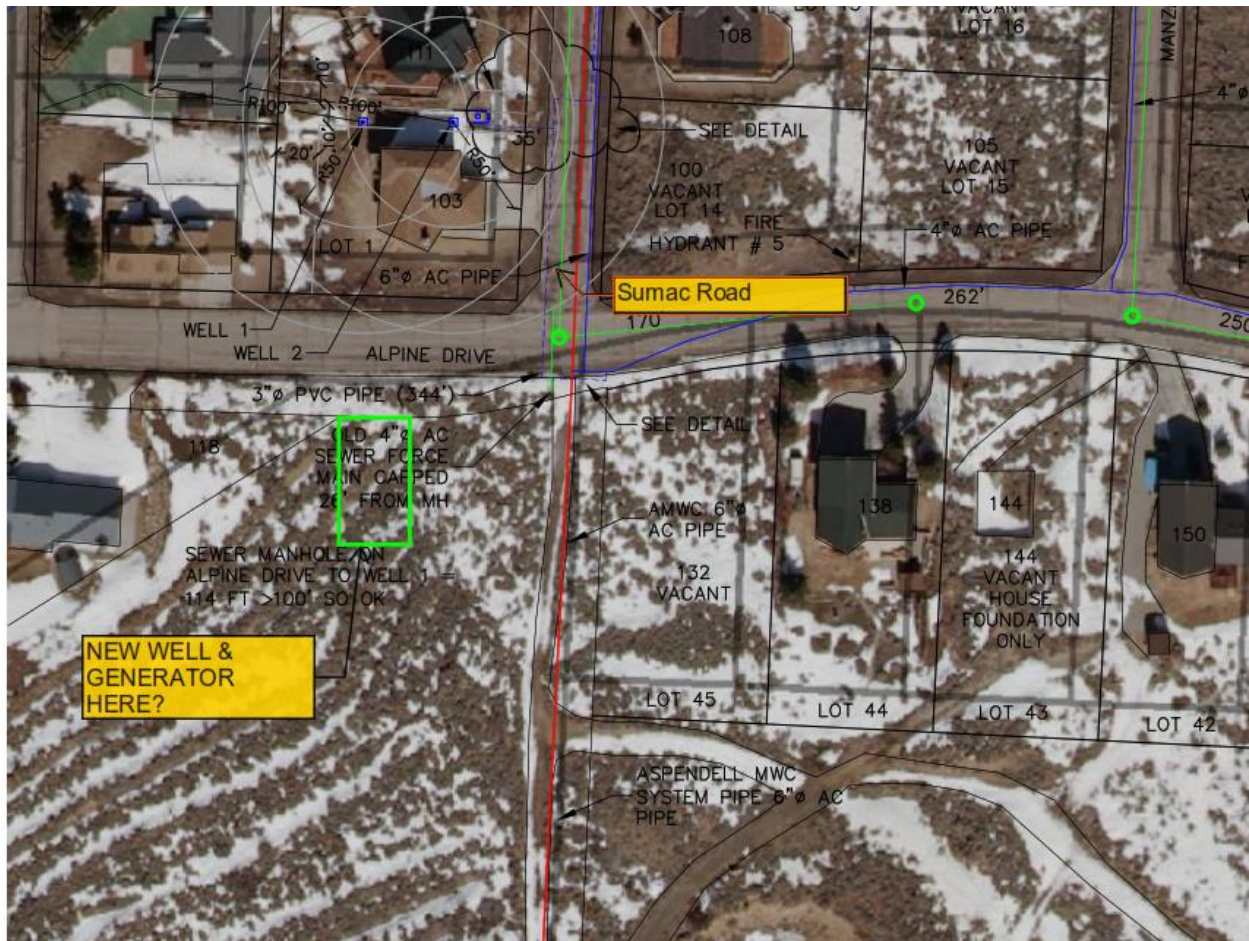
Possible location of a higher capacity well & generator facility.

It is close to the road and can have the drive way plowed. It fits the required distances from the sewer & manhole and from building sewer.

It could also include a PRV to step the pressure down to provide water to Aspendell MWC & a pumping station to boost the pressure from AMWC up to Alpine Water Company.

Alpine Water Company could ask Aspendell MWC for an easement or sell them a piece of the parcel.

All other locations are on Tony's property far off the paved & plowed road. They would need to be 100 ft from a sewer manhole and 50 ft from a sewer pipe or house sewer pipe.
